TD-11-010
August 5, 2011

RRP Cable Damage Analysis for LARP Coils LQ 09 and LQ 13

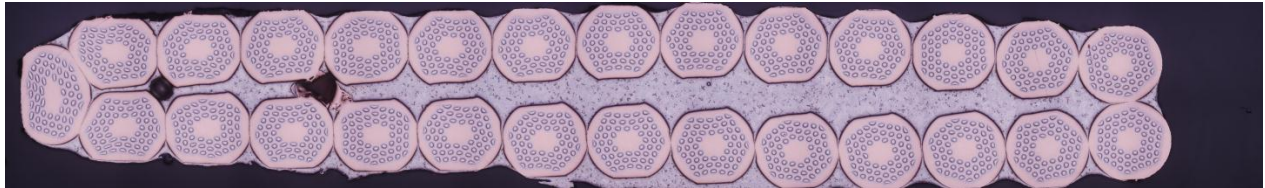
Figure 2: In this case, the thin edge of the cable is on the left – the strands on the left are flattened to a greater degree than those on the right.

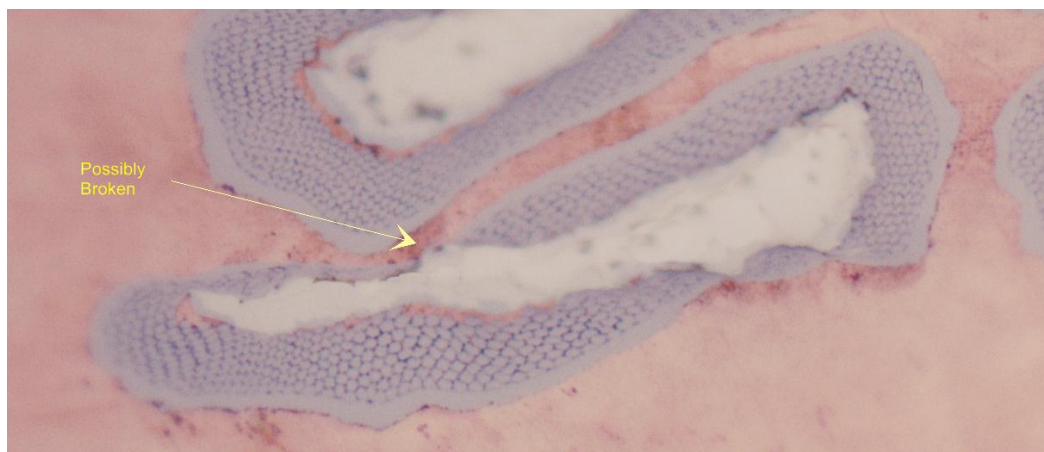
Figure 4: Possibly broken subelement.

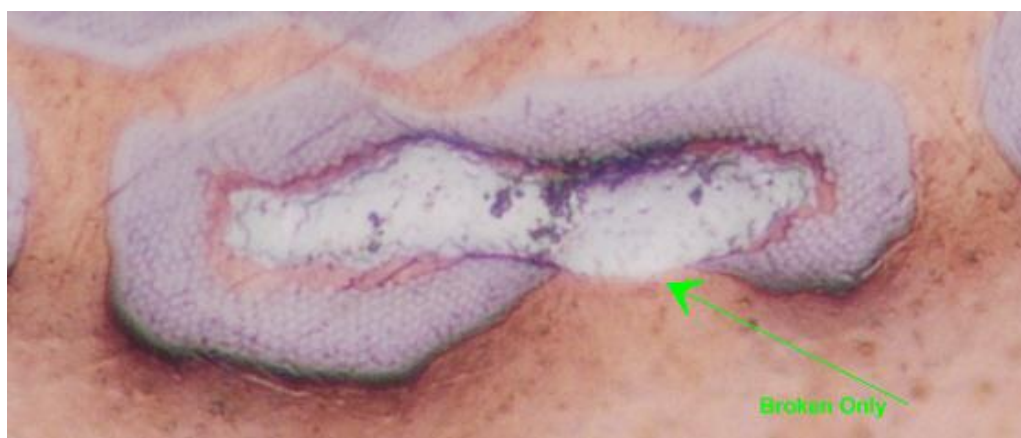
Figure 5: Broken subelement.

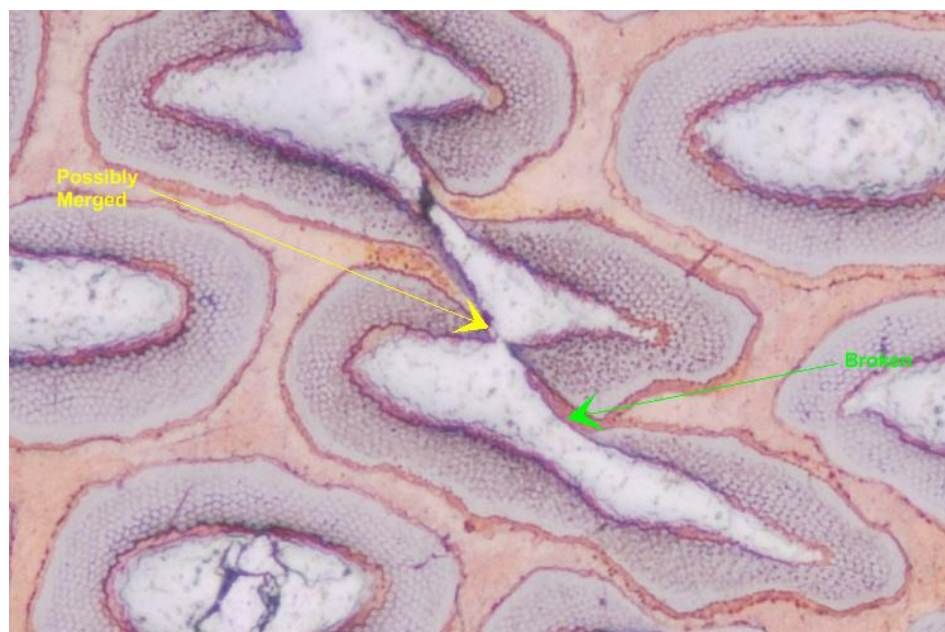
Figure 6: Broken and possibly merged subelements.

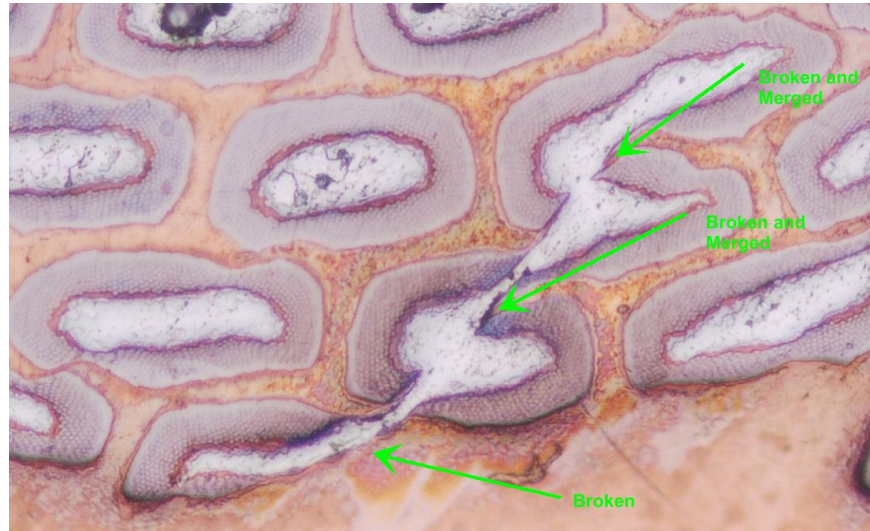
Figure 7: Broken and merged subelements.

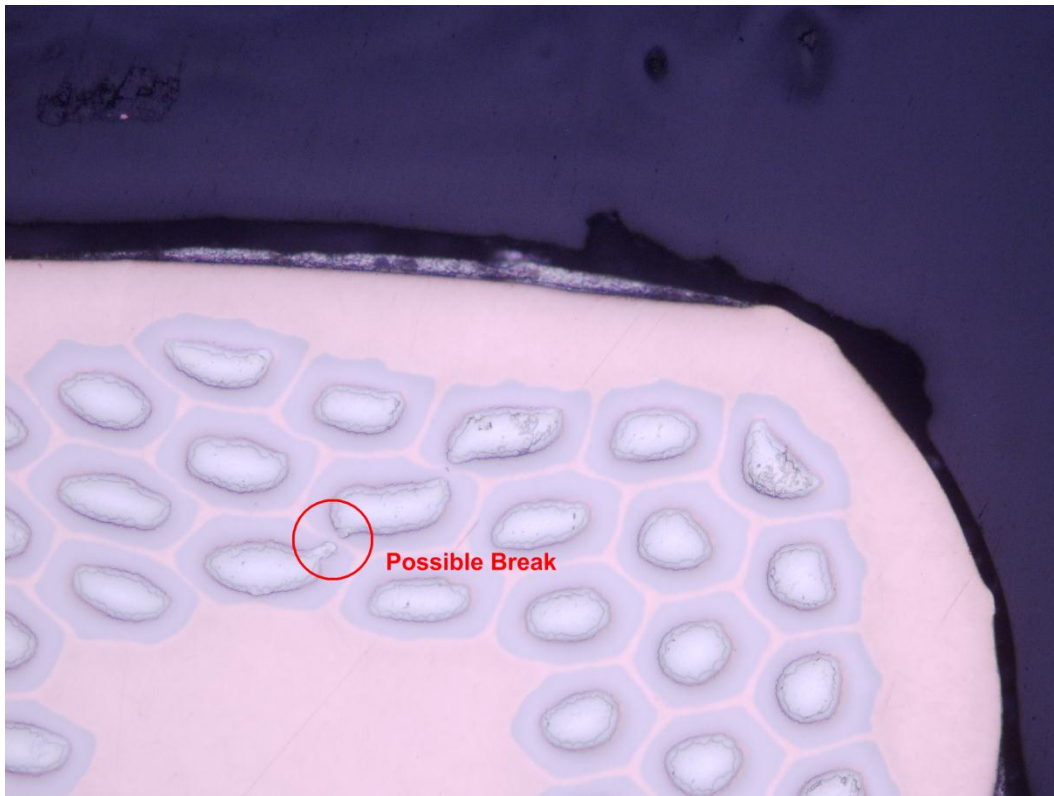
Figure 8: LQ 09 Cross Section 4, strand 1 at 20x magnification.

The pictures above represent all of the apparent problematic areas in all 12 cross sections of the LQ 09 and LQ 13 cables. Only two areas with the possibility of damage were observed, and higher magnification clarified that no damage existed in either case. Although a complete lack of damage is not unheard of, even good cables generally show at least two to three damaged subelements when six cross sections are analyzed. A comparison to other recent 27-strand cables is shown below in Figure 12.

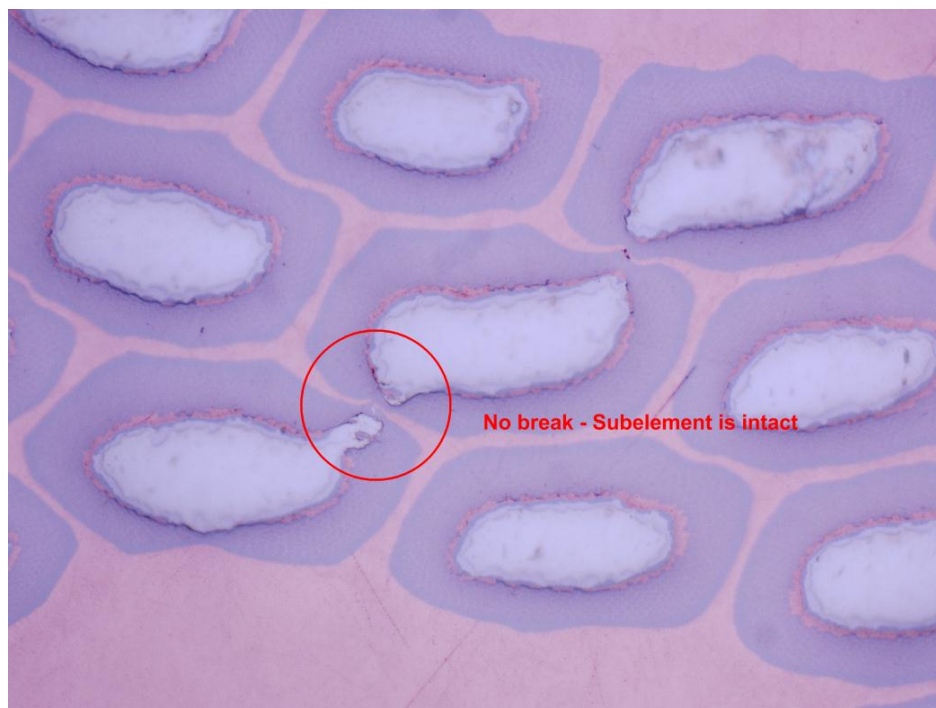
Figure 9: LQ 09 Cross Section 4, strand 1 at 50x magnification.

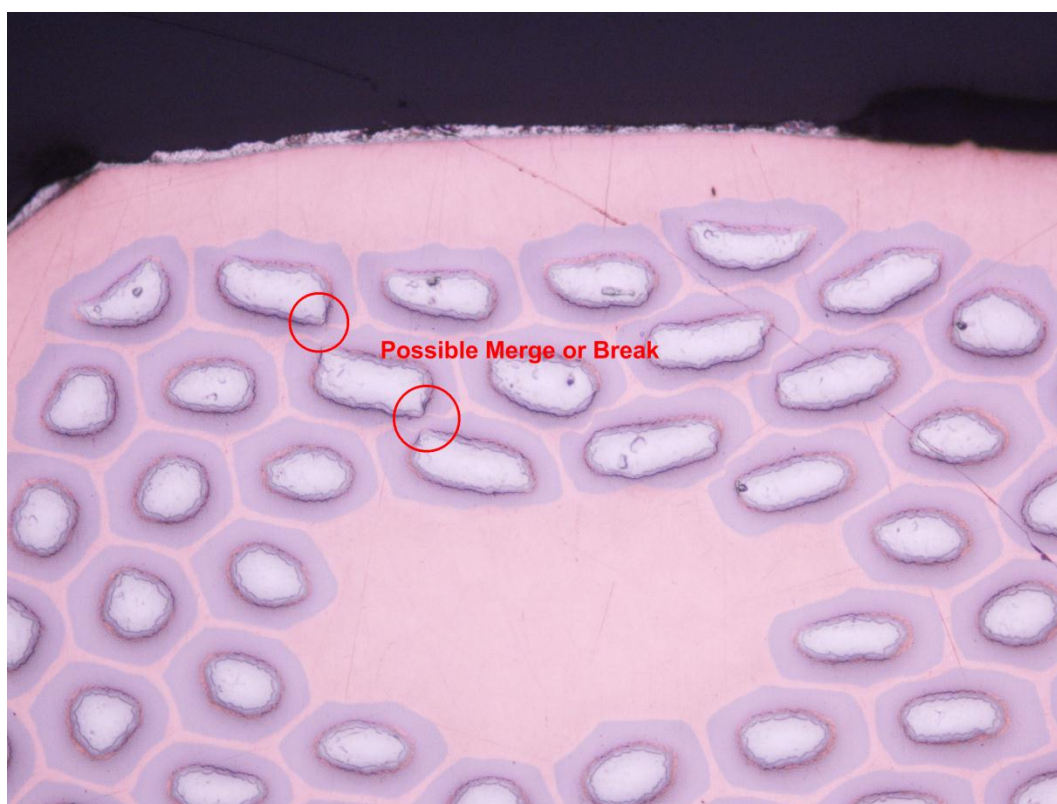
Figure 10: LQ 09 Cross Section 1, strand 1 at 20x magnification.

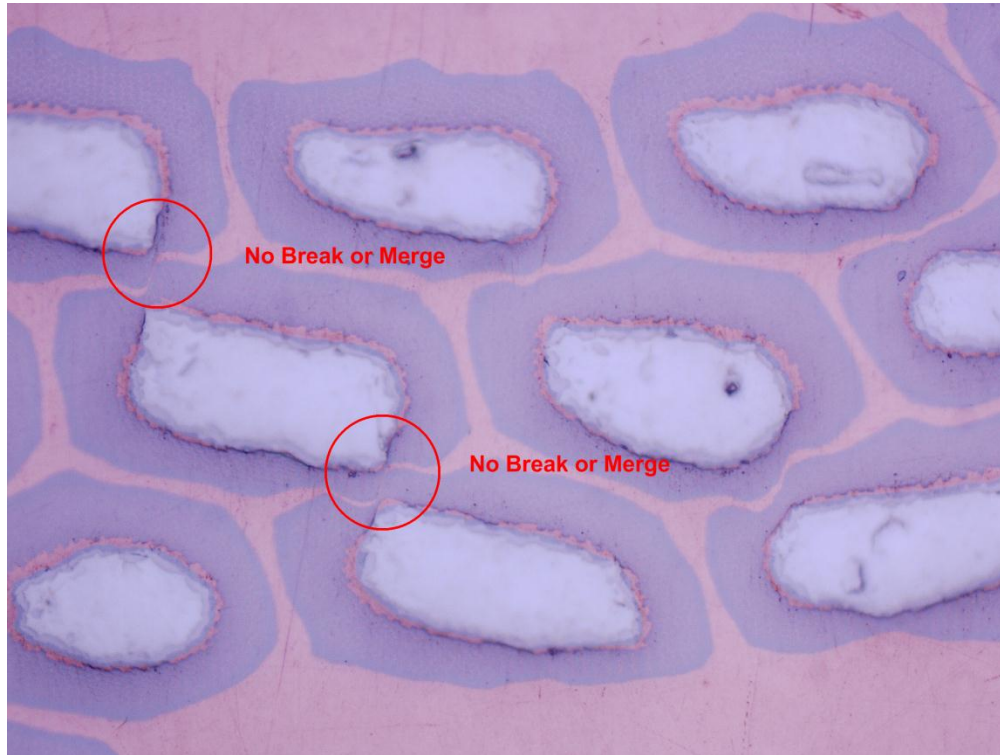
Figure 11: LQ 09 Cross Section 1, strand 1 at 50x magnification.
